TRECOM TECHNICAL REPORT 63-10

Automatic Light Aircraft Readiness Monitor

Project ALARM

VOLUME I

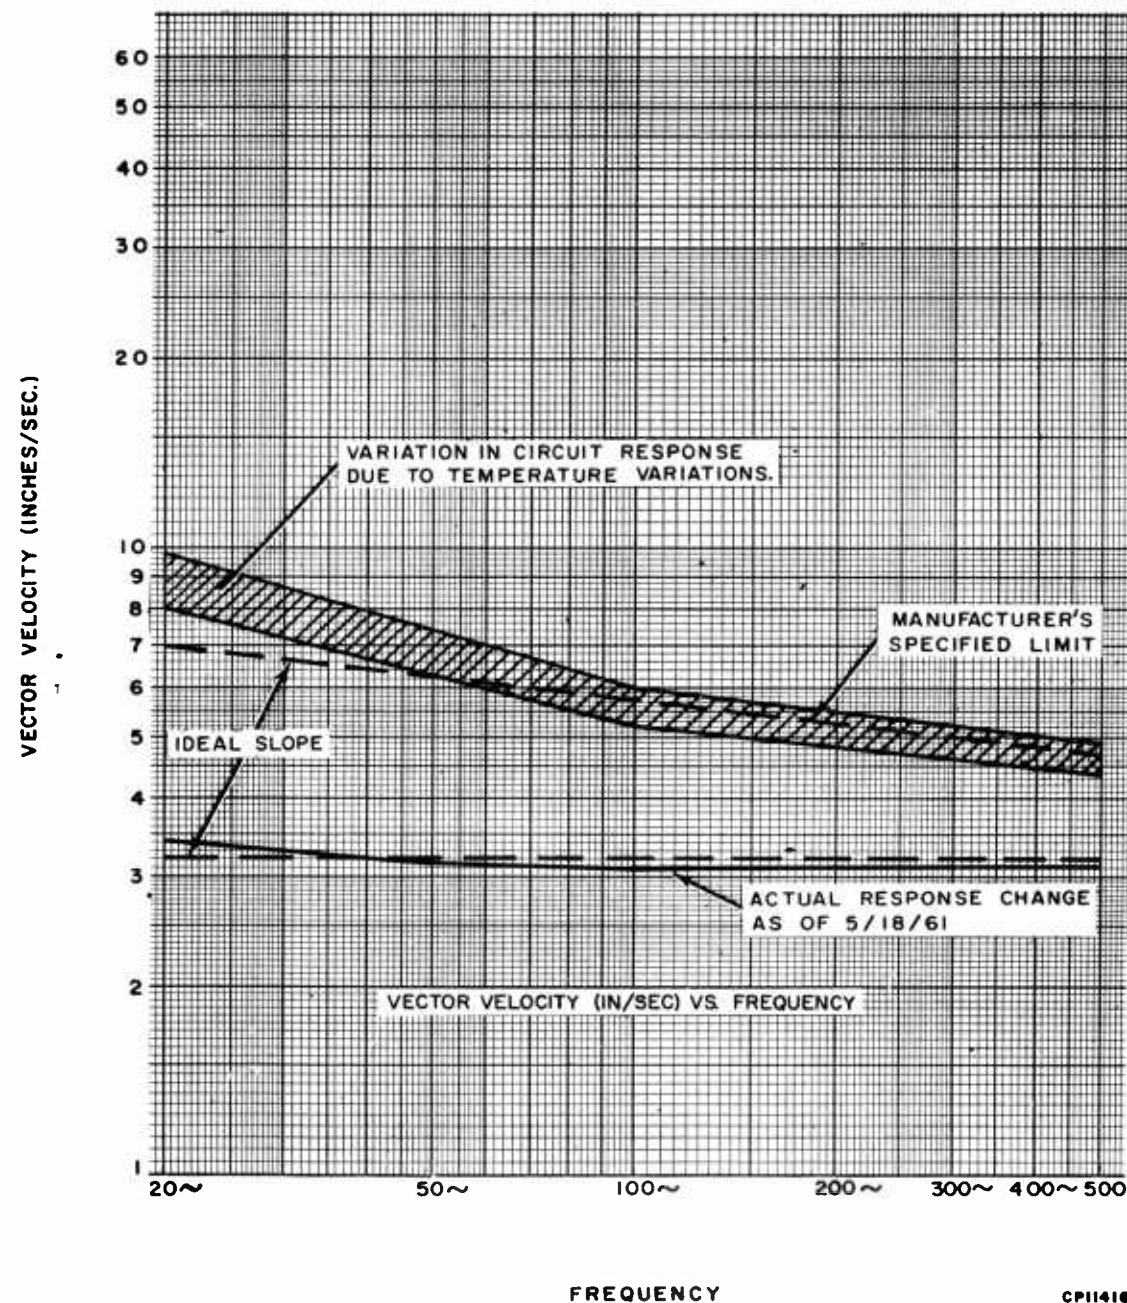
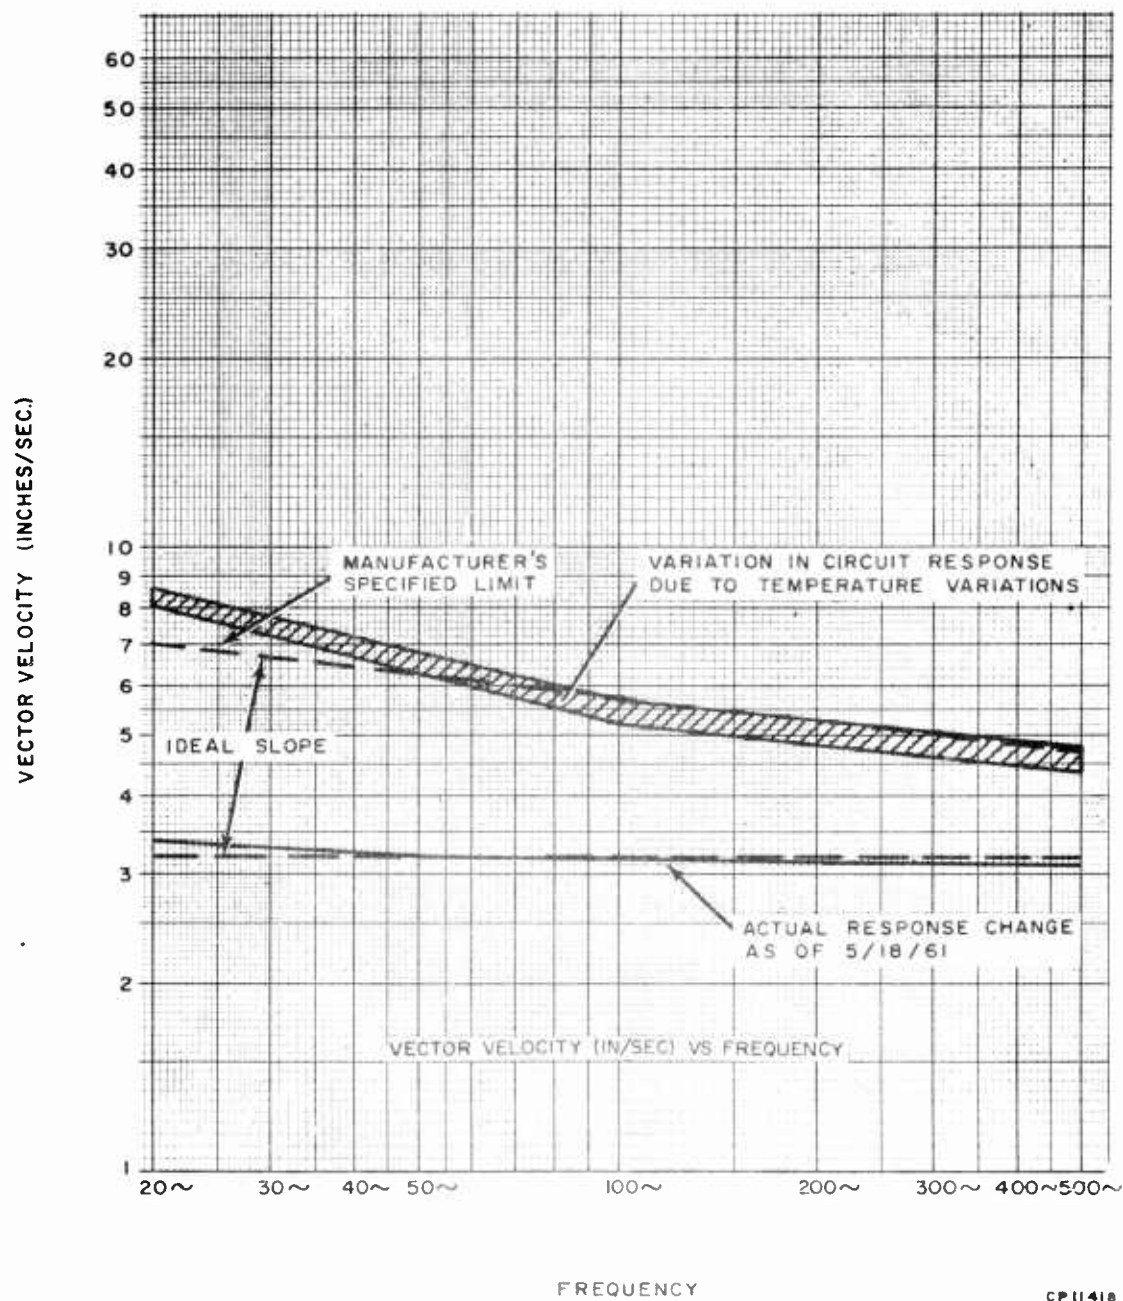
The next five illustrations (7 through 12) show essentially the same categories of data concerning Engine Vibration Channels. Note particularly in Figures 7 and 8 the change made to the detection level; this resulted when it was realized the original detection level, as specified by the manufacturer, was too high to permit any realistic indication of any engine difficulty. At the same time, the ideal slope of this response was changed to a uniform response across the frequency band, at 3.2 inches/second. Even at this decreased detection level, at no time during the Operational Tests did an indication occur on these Channels, verified by observing the maximum amplitudes of plots on Figures 9, 10, and 11. This caused an even further decrease for the detection level used in the Malfunction Tests which are detailed in this document.

FIGURE 7. CHANNEL SENSITIVITY, AFT ENGINE VIBRATION, PLOT

FIGURE 8. CHANNEL SENSITIVITY, FWD ENGINE VIBRATION, PLOT

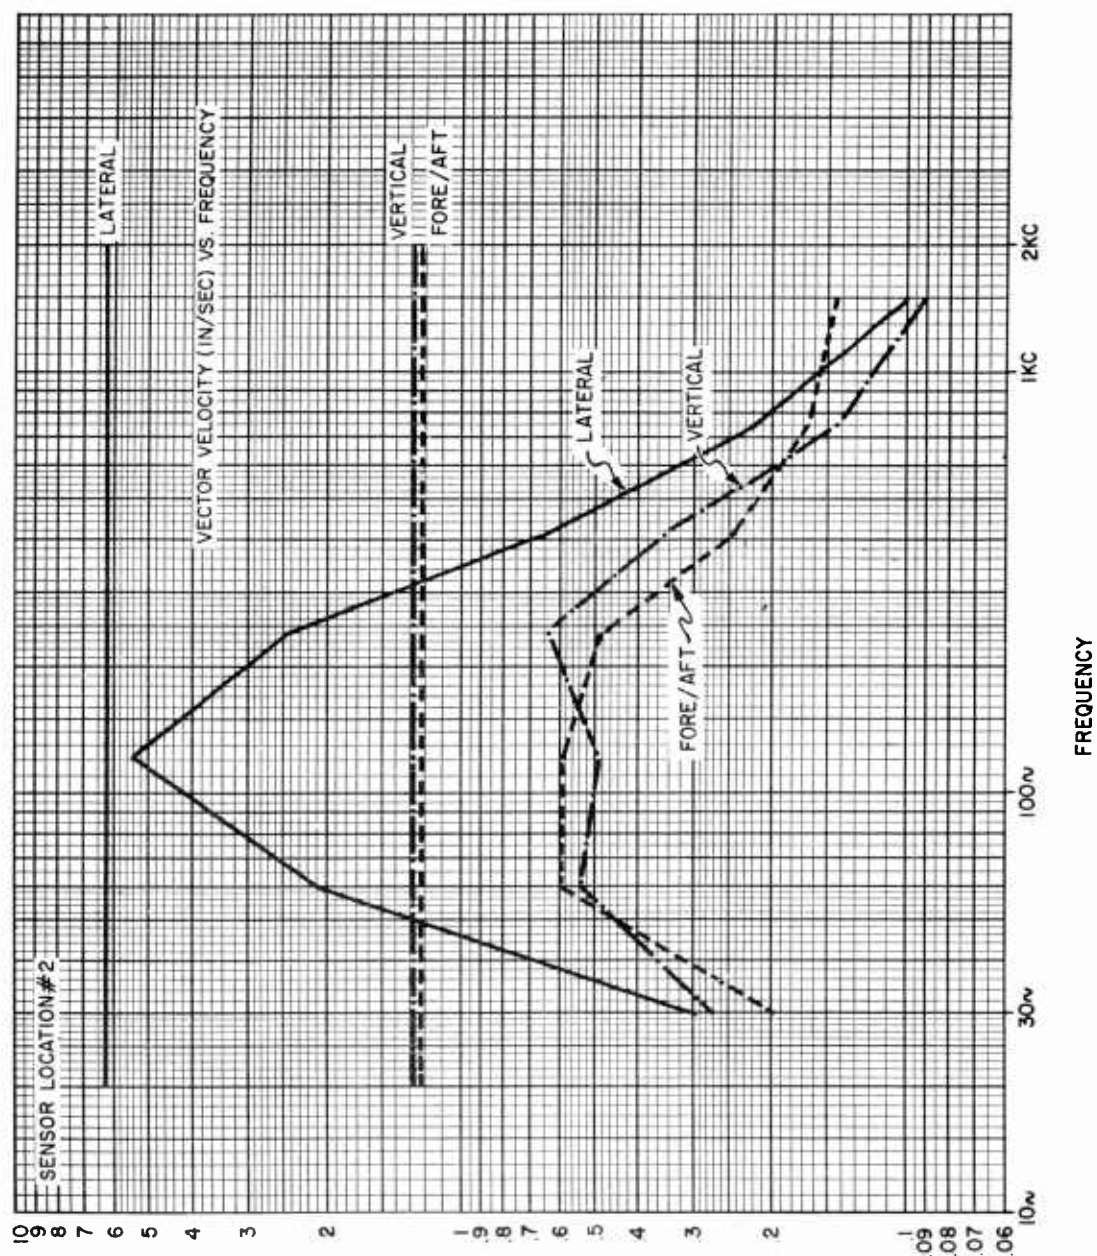
The results of a 3-plane study of tail vibrations, shown in Figure 15, revealed predominate lateral vibration occurring, but it was suspected that the method of sensor mounting for this test resulted in some structural resonances. The sensor was mounted on a solid block of aluminum that had been welded to an aluminum sheet which replaced an inspection panel. This gave a large mass mounted to a thin and flexible base. The data collected while employing this mounting then had to be considered as questionable in value. Final changes were made to the location and mounting, predicated by qualitative analysis of all of these earlier tests. The sensor was eventually mounted on the 90° Gear Box and oriented to transduce the vertical and fore-and-aft planes. This location (#3) was used for the subsequent Malfunction Tests.

FIGURE 15. TAIL VIBRATION, VECTOR VELOCITY VERTICAL, LATERAL, FORE/AFT PICKUP ORIENTATION

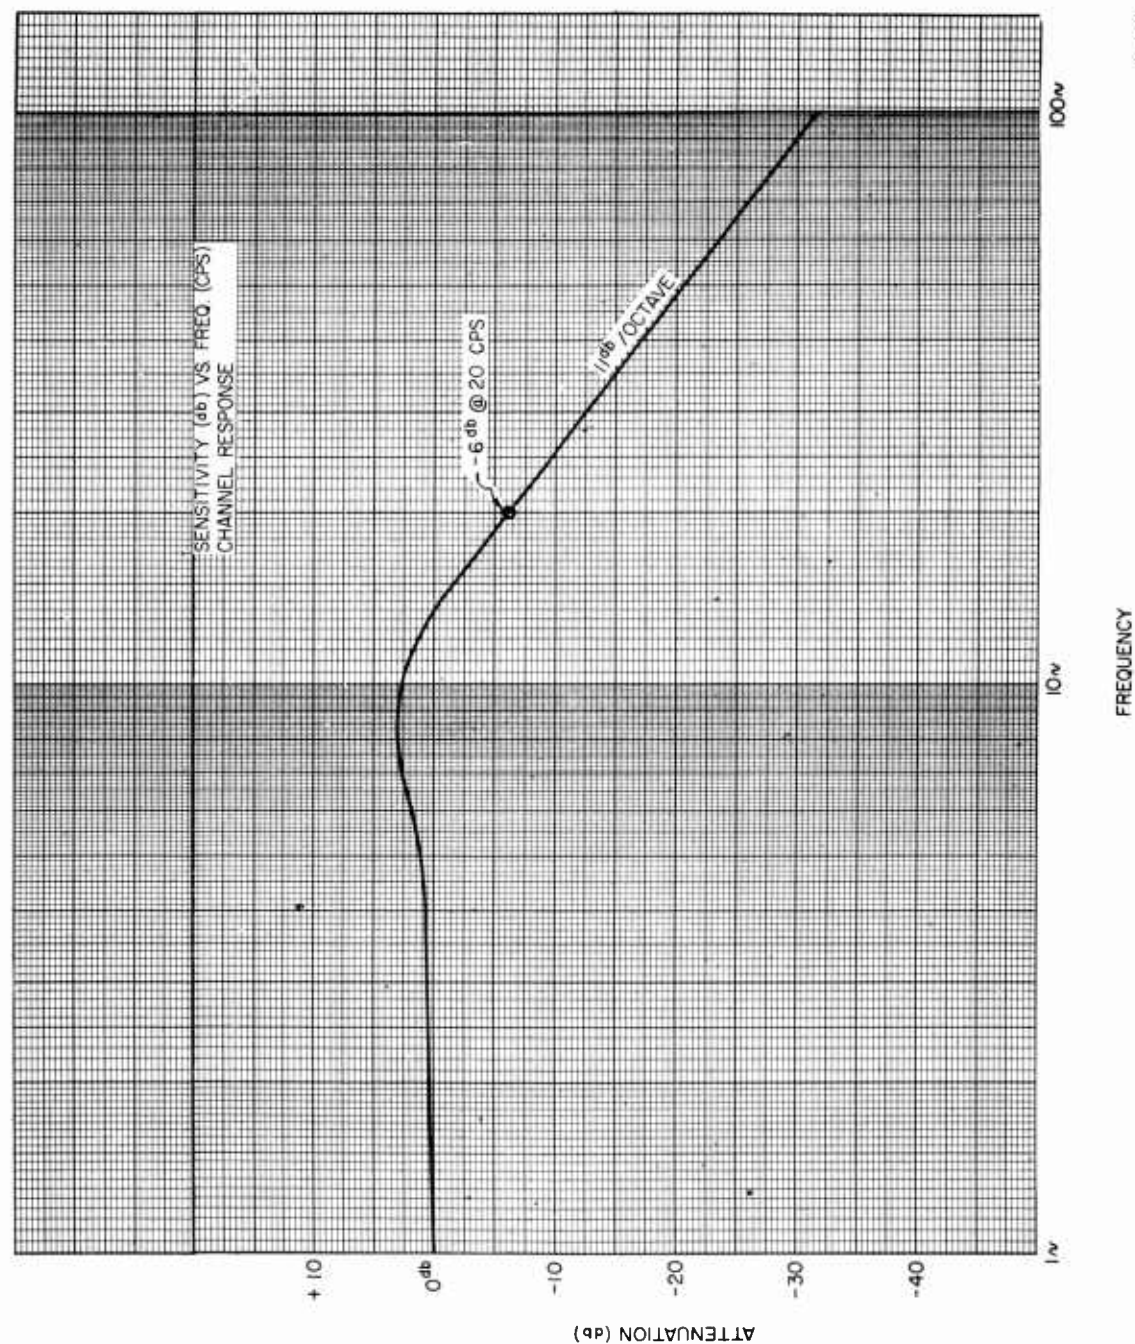
g-levels were so small that noise was adversely affecting the channel. This led to the adoption of a velocity-type pickup, which was located in the forward part of the aircraft fuselage to transduce low-frequency frame vibrations in the order of 1 and 2/rev. This effort was accomplished during the Malfunction Test sequence after the aircraft had been grounded, and no operational data were accumulated. Figure 16 shows the response curve of the modified channel used for the Malfunction Test.

FIGURE 16. LOW FREQUENCY MAST VIBRATION, SENSITIVITY VS FREQUENCY, 1 AND 2 REV.

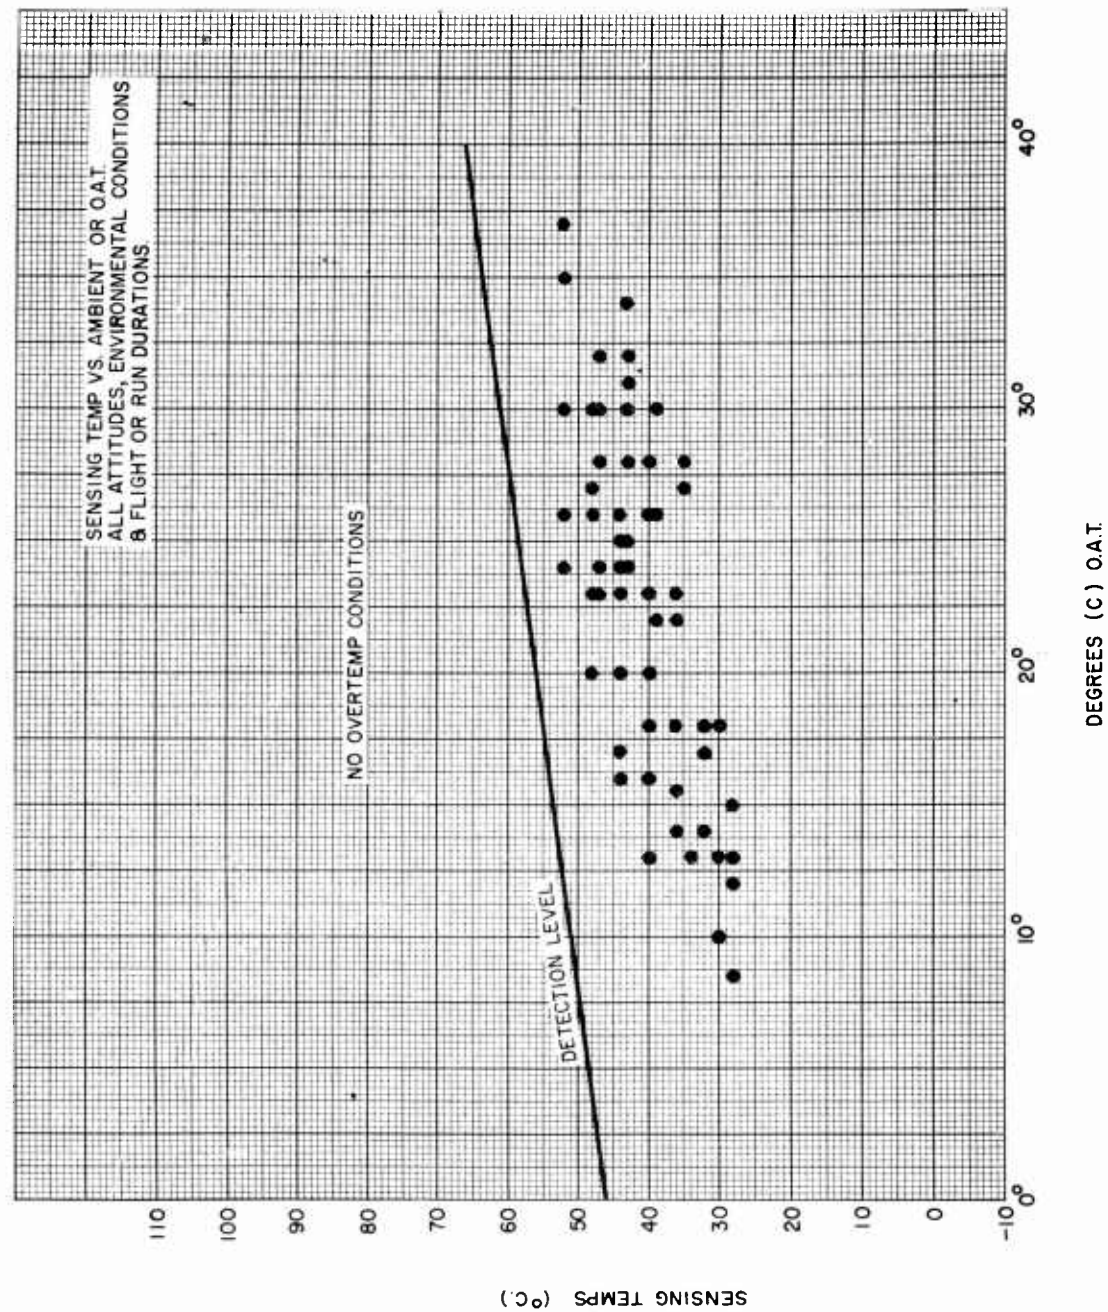
As can be observed in Figure 17, Part 1, no abnormal temperature conditions were encountered on the Swashplate Bearing throughout the Operational Tests. Measured temperatures ran somewhat below the detection level, and later malfunction tests supported the decision to lower the detection level 5°C uniformly across the ambient temperature range.

FIGURE 17. SWASH PLATE BEARING TEMPERATURE PLOTS (PART 1)

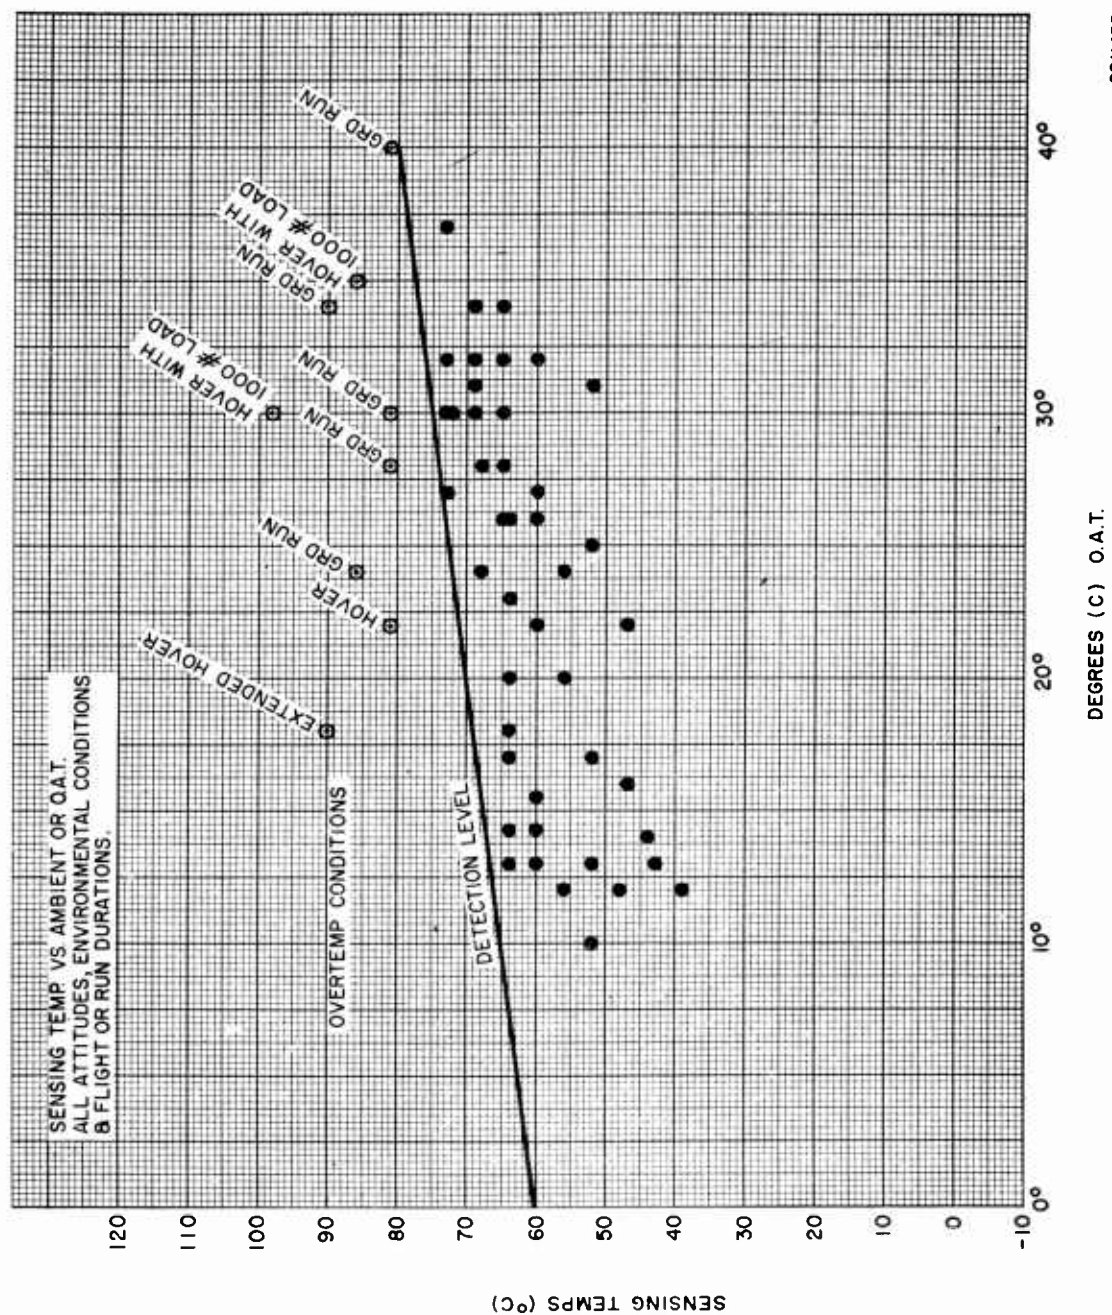
The data on Part 2 of Figure 17 show the behavior of the temperatures recorded from the Main Mast Brg sensor. As a result of the Operational Tests, it was apparent that the temperatures as monitored by the ALARM thermal ribbon were very closely related to the XMSN Oil Temperature as indicated on the aircraft instrument panel. ALARM indications would occur on this channel when the oil temperature reached "red-line" value of $+110^{\circ}\text{C}$ during attitudes such as extended hover in hot, humid weather. It was resolved to eliminate this location for the reasons detailed in the Malfunction Test Results section of this report.

FIGURE 17. MAIN MAST BEARING TEMPERATURE PLOTS (PART 2)

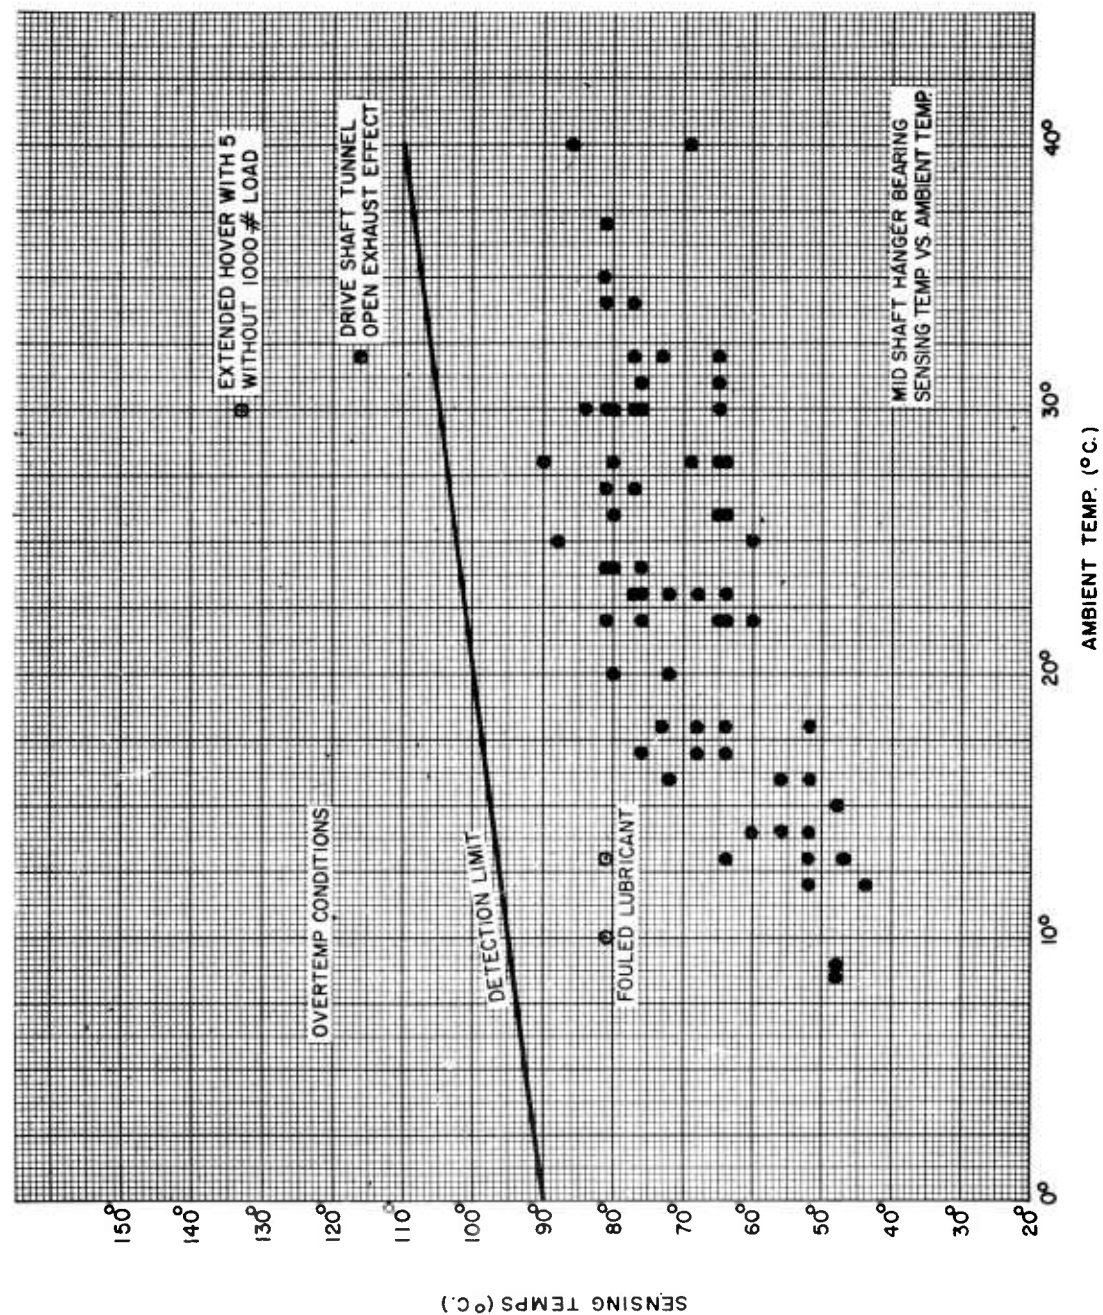
Data on the three Shaft Hanger bearing monitors are shown on Figure 18 and Part 1 of Figure 19. These data represent the accumulation during both Operational and Malfunction Testing. Early in the Operational Test programs, an indication occurred on the Mid Shaft Bearing and upon examination was found to have been caused by contaminated lubricant in the bearing. Upon removal and relubrication, the operating temperature dropped appreciably. This condition was repeated at various times and substantiated. Subsequent periodic indications during extended hovers in high ambient temperatures led to increasing the detection limit to avoid some of these conditions. The hover indication at high ambient temperatures is such that it should be heeded before catastrophic damage to the bearing occurs. It is suspected that the three hanger bearings were all operating at a higher than normal temperature because of the behavior experienced on the Mid Shaft Bearing. All three of these limits may eventually be reduced.

FIGURE 18. MID SHAFT HANGER BEARING, SENSING TEMPERATURE VS AMBIENT TEMPERATURE (PART 2)

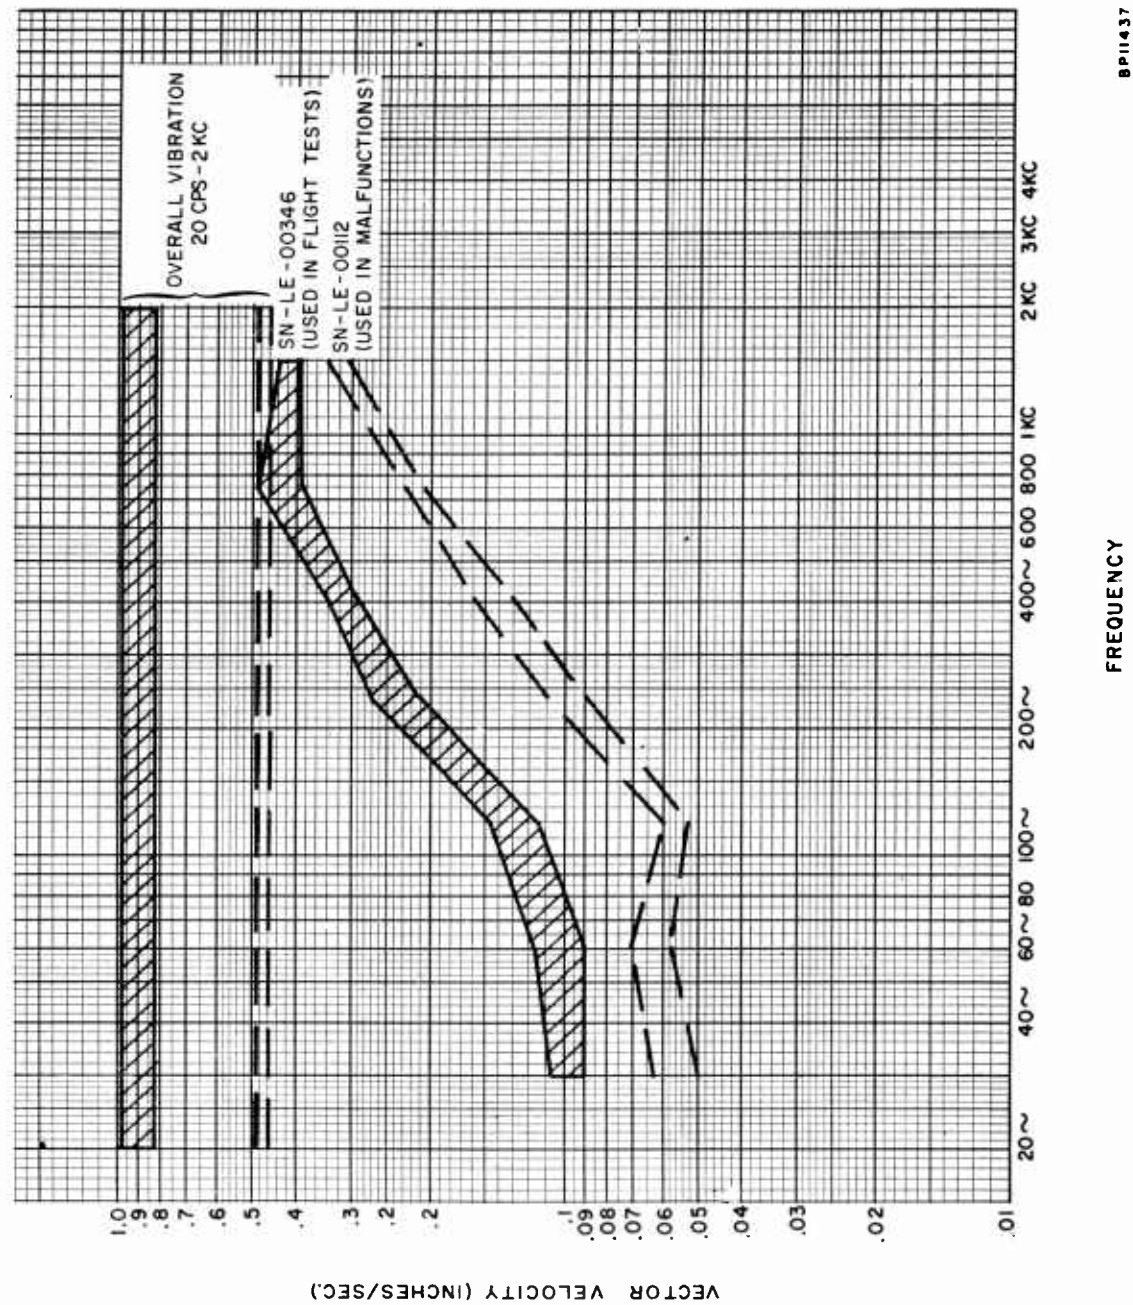
Prior to actually commencing the malfunction test sequences on the turbine engine, an investigation of the forward engine vibration pick-up was made as a result of an analysis of previous data recorded from that channel. It was suspected that the pick-up mounting pad arrangement was creating some resonances which were masking actual vibrations. A modified pad was manufactured and the results are shown in Figure 25. This modification will alter the actual vibration levels as recorded during Operational Tests of this channel, but it is felt that the relative amplitude differences at the various flight attitudes are still valid. The modified pad was used throughout the Malfunction Tests.

FIGURE 24. FWD ENGINE VIBRATION, ORIGINAL VS MALFUNCTION PLOT

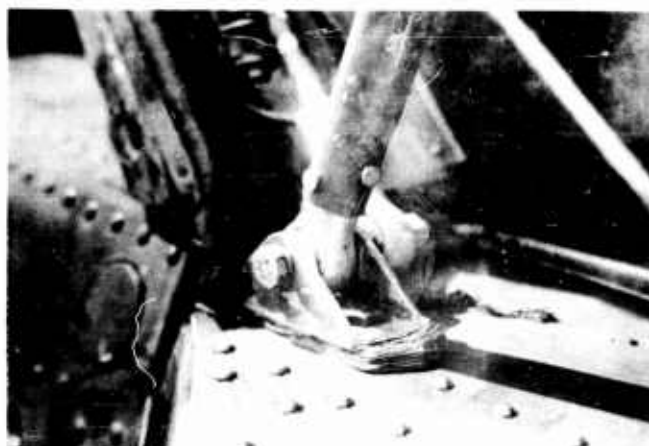
Figure 26. Right Rear Engine Mount and Shims, Short Shaft Misalignment Malfunction Test.

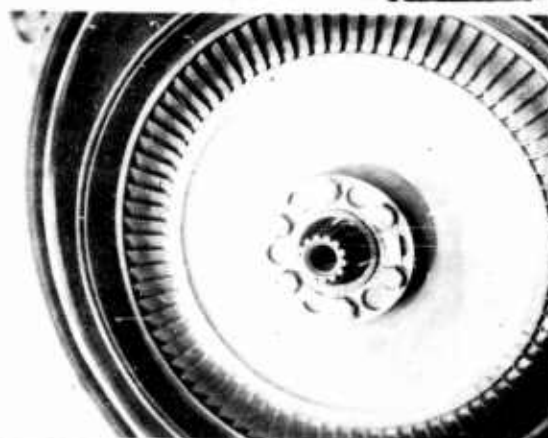
For this test, a series of N₂ turbine wheel rotations were performed as illustrated in Figures 29, 30 and 31. On the first removal, the turbine wheel was carefully marked for reference position on the power shaft, then rotated 90° and reassembled. After that test run, the operation was repeated, placing the turbine wheel at 180° from reference, and another data run conducted.

Figure 30. N2 Turbine Showing Marks Used To Determine Location For Turbine Wheel Rotation Unbalance Test.

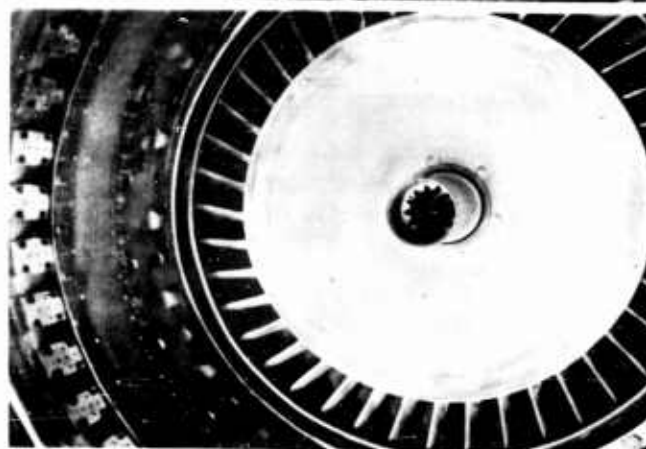
Figure 31. N1 Turbine In Preparation For The Turbine Wheel Rotation Unbalance Test.

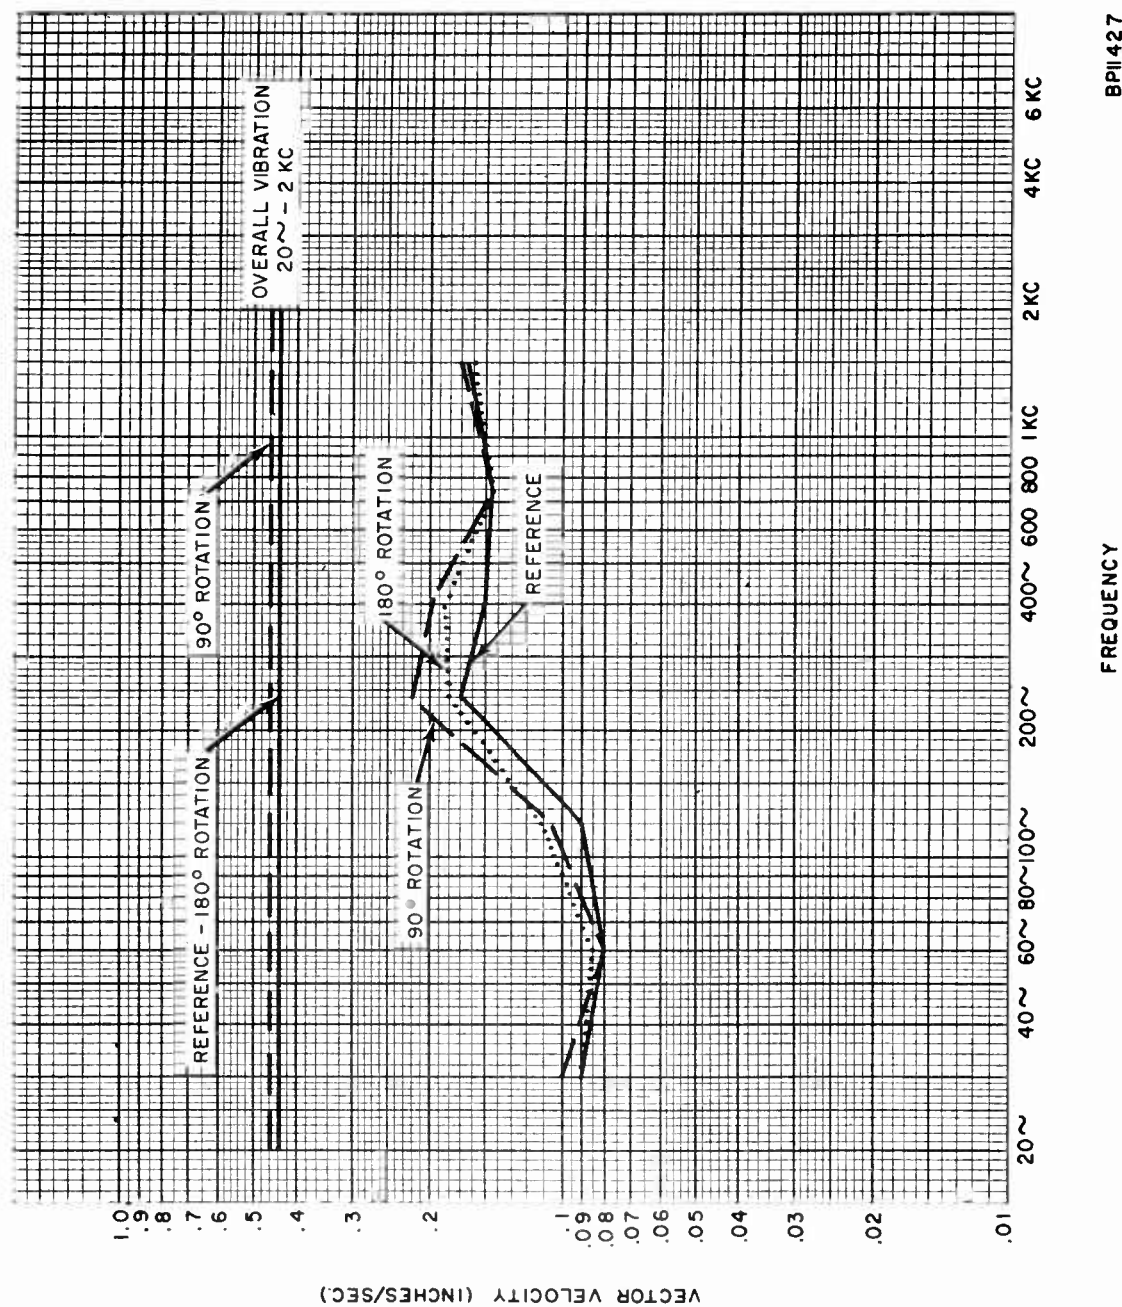
Results of these tests are illustrated graphically in Figure 32 and Figure 33. As shown on the data plots, the most significant vibrational increases

FIGURE 32. AFT ENGINE VIBRATION, VECTOR VELOCITY VS FREQUENCY, PLOT

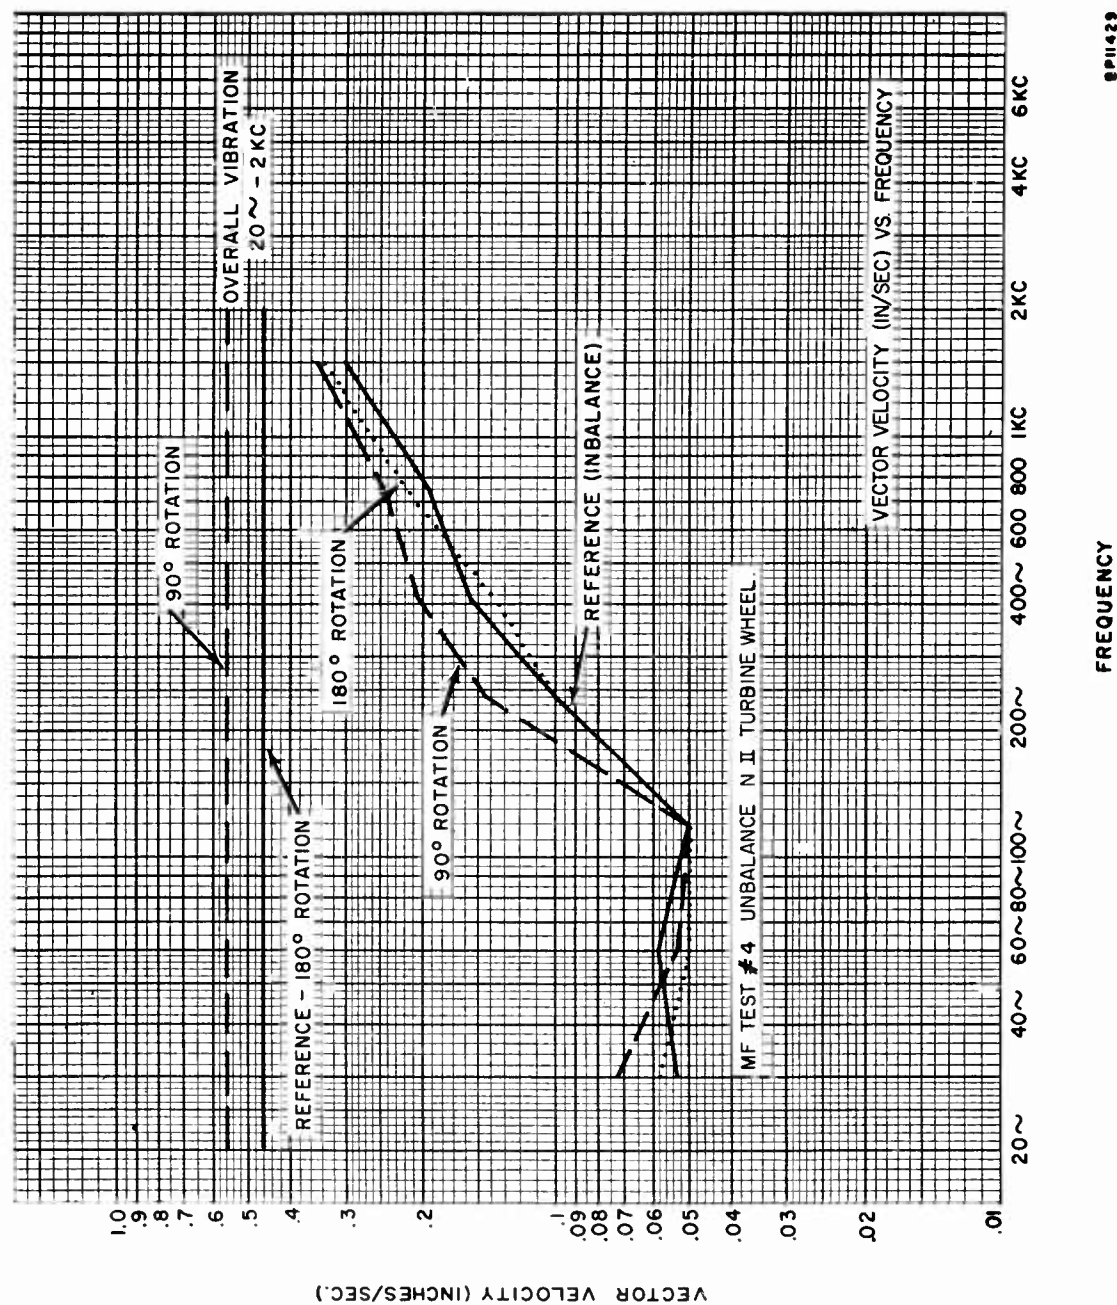
FIGURE 33. FWD ENGINE VIBRATION, VECTOR VELOCITY VS FREQUENCY, PLOT

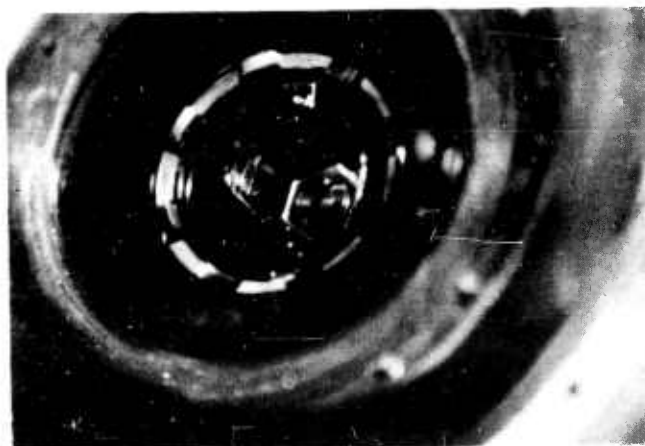
Figure 38. Power Shaft Bolt And Lock Assembly. (Loss of torque, N2 torque wheel mounting bolt, engine malfunction test).

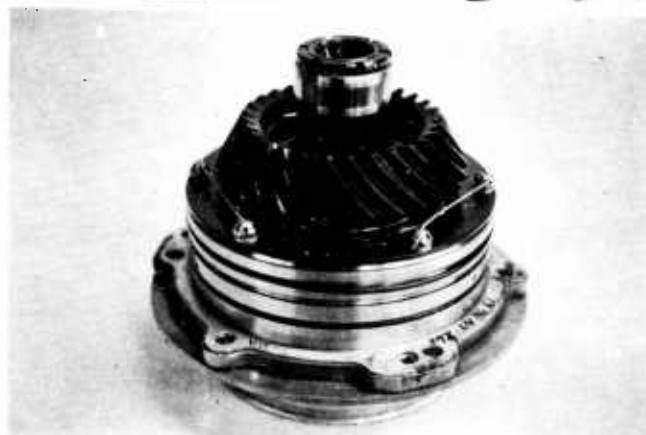
This test was performed by utilizing the Input Quill (shown in Figure 44) removed from another transmission due for overhaul (S/N A12-142). The quill was disassembled to the bevel gear/bearing set, and this portion was subjected to heat treatment to reduce hardness of the gear from Rockwell C 60 to Rockwell C 40. After reassembly and installation in the malfunction transmission (S/N A12-78), the Xmsn Base vibration indicated immediately. Data results are shown in Figure 45 and Figure 46. The Top is shown for reference only; no indication occurred on this channel although some variation is indicated.

Figure 44. Main Transmission Input Quill Prior To Annealing.

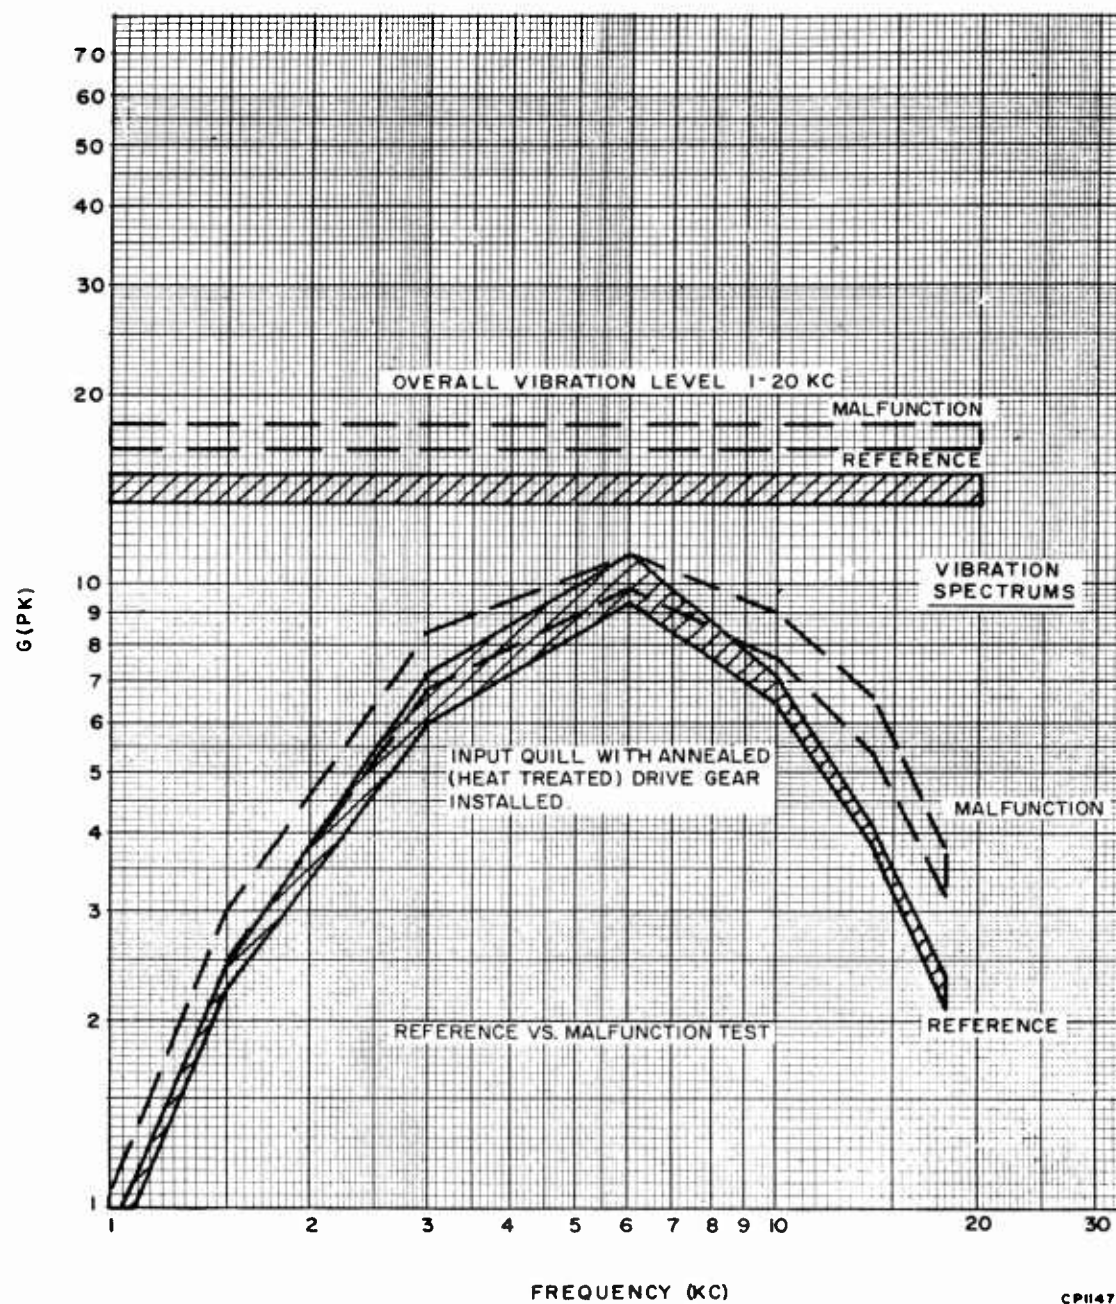
FIGURE 46. XMSN BASE VIBRATION

It should be noted here that even though the top transmission sensor output was not easily distinguishable between normal and malfunction operation, the base transmission sensor output was much more discriminate, as shown on Figure 46. Here the normal operation level was at an over-all peak of approximately 15g. The malfunction operation appeared as a minimum of 18g over-all. The differential in this case is large enough to give a valid "GO/NO-GO" indication.

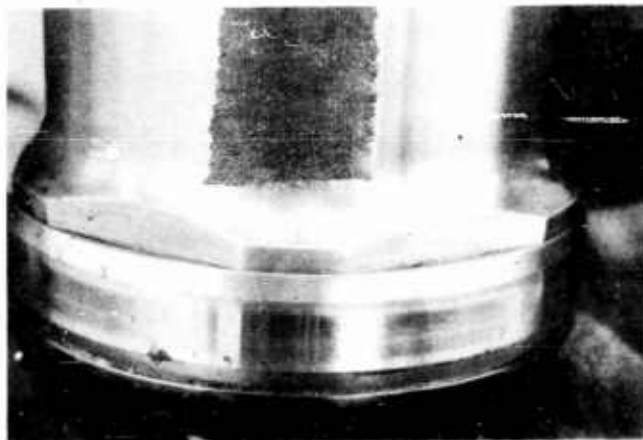
Figure 47. Lower Mast Bearing Race Before Malfunction Test, Main Transmission.

The Main Mast Assembly was removed from the aircraft and the lower mast bearing inner race (see Figure 47 for reference) was ground off to create a 0.015-inch "flat" on the surface as shown in Figure 48. The 0.015-inch dimension represents the depth of the "flat" from the true round of the race.

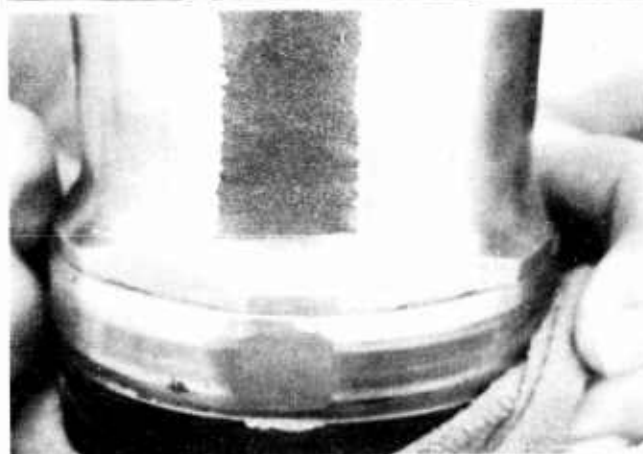
Figure 48. Lower Mast Bearing Race, With 0.015 Inch Flat.

On reinstallation of the main mast and main rotor assembly, test runs were conducted, with the results proving negative. No Xmsn Base vibration increases were detected at any time. It is felt that the "flat" did not create any pronounced bearing impacts as had been anticipated; hence it is considered a poor malfunction test, if a malfunction at all. Here also the overhaul report may reveal additional considerations. For example, if substantial bearing deterioration has occurred, it will indicate this was a true malfunction condition and as such is not detectable by vibration as monitored in the ALARM System.

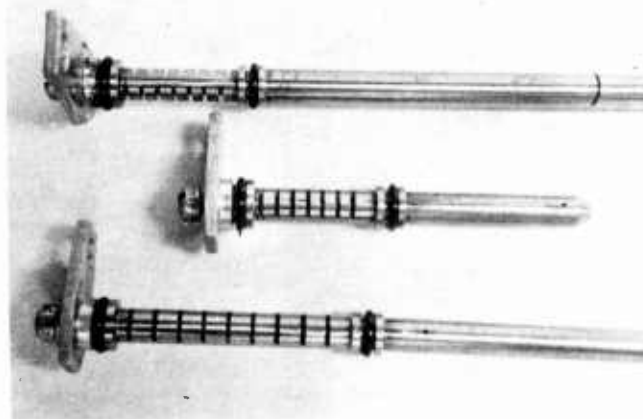
Figure 49. Main Transmission Lubricating Jets.

Tests in this area involved the three main transmission lubricating jets shown in Figure 49. Initially it was planned to silver solder the small jet openings closed, but later it was decided to tape the input slots closed for complete blockage.

The first test was to create an increased oil pressure condition for relief valve (Channel 19) operation, and one blocked jet was installed. No indication occurred, and the oil pressure increased as read on the aircraft Xmsn Oil Pressure gauge. The remaining two jets were blocked and the pressure rose from 40 psi to nearly 70 psi. No indication on the Pressure Relief Valve channel occurred. To check proper operation, a regular (unmodified) relief valve was installed and the tests repeated. Pressure increased a total of 8 psi, thus proving that the

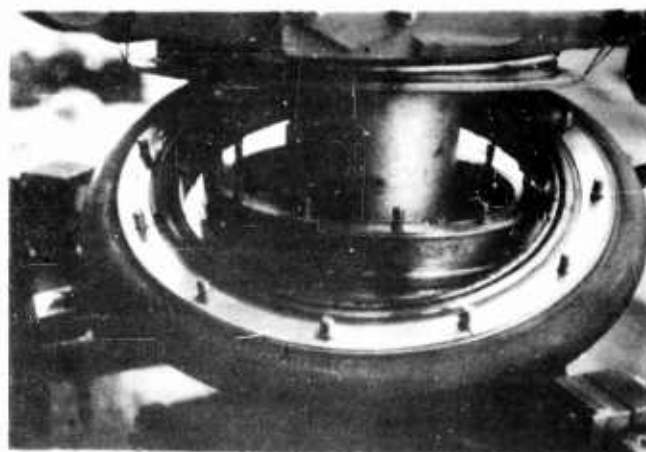
Figure 51. Swashplate Bearing Removed.

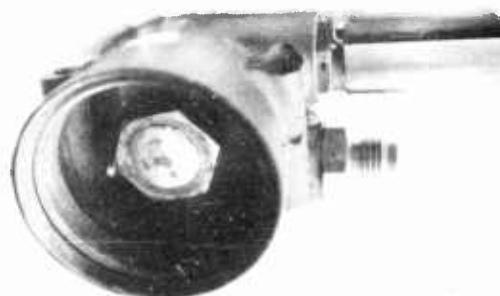
Figure 52. Fuel Filter With Blocking Plug Installed For 100% Fuel Bypass Test

At the time this particular test was conducted, the transmission and engine oil filter switches were still functioning properly and provided proper "NO GO" indication immediately. The fuel filter switch was defective and no valid indication occurred. Of equal importance was the observation that with 100% blockage of the filters, both the transmission oil and fuel pressures as indicated on the aircraft gauges did not change more than 1 or 2 psi from the reference pressures (filters clear). The engine oil pressure decreased 20 psi but it remained within the "green" area of the gauge. Thus it is established that blocked filters are not detectable by abnormal pressures in the associated systems, verifying the feasibility of these channels designed to indicate when the filters should be removed and cleaned.

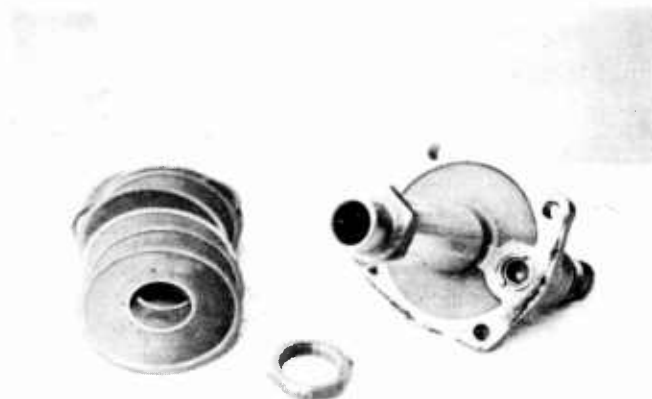
Figure 53. Transmission Oil Filter With Blocking Element Installed.

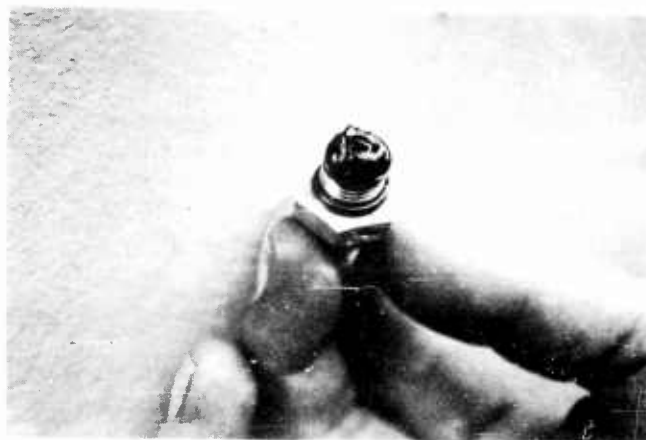
Figure 58. Sludge Accumu-
lation, 90° Gear Box Chip
Detector.

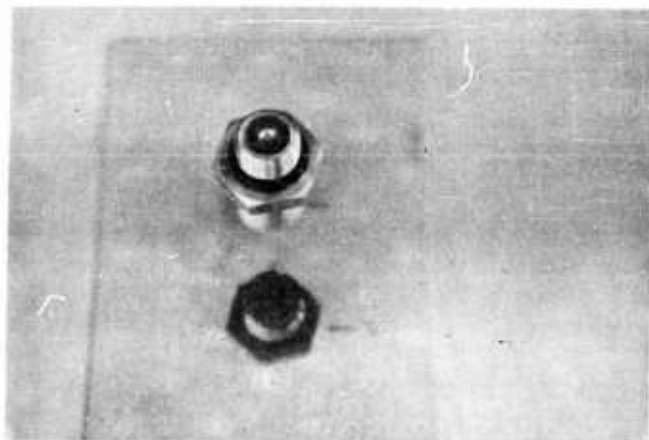
In direct contrast to the results obtained on the 90° Gear Box, the addition of almost 2.5 grams of filings in the 42° Gear Box failed to provide indication. As shown in Figure 59, the detector accumulated practically no particles. The test was repeated using the original magnetic plug and it too failed to accumulate any appreciable amount, as shown in Figure 59. This was considered to be entirely due to the location of the plug within the gear box, and further investigation indicated the plug should be relocated, if possible, to the lowest point in the main reservoir area rather than out along the input quill section of the housing as at present.

Figure 59. 42° Gear Box
Chip Detector After Addition
Of 2.5 Grams Of Particles.
